**Report No: RJ5053P-1-Rev.1**

**Date: October 4, 2016**  
**Revision Date: October 7, 2016**

**TEST REQUESTED:** Impact testing on architectural wall panels per ASTM E 695-03 (Reapproved 2009), *Standard Test Method of Measuring Relative Resistance of Wall, Floor, and Roof Construction to Impact Loading* modified to simulate infield installations.

## **IMPACT TEST PER ASTM E695-03 MODIFIED TO SIMULATE INFIELD INSTALLATIONS**

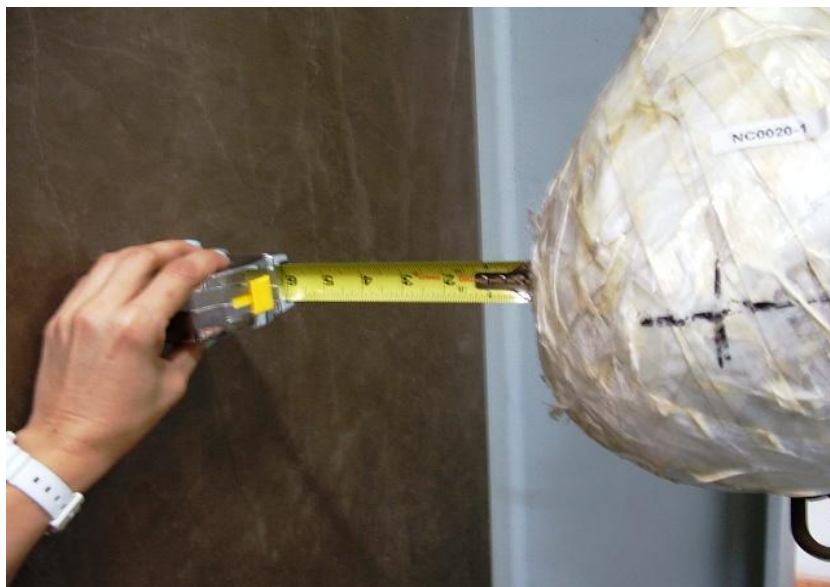
For each of the three wall assemblies tested, cracking of the porcelain finish occurred after being subjected to an impact force of 100 pounds at a distance of 30". This would be *approximately* the equivalent of a 100 pound object impacting the wall at a velocity of 6.5 feet per second or 4.4 miles per hour. No structural damage to the porcelain finish or aluminum framing members occurred. No separation or failure of the wall assembly's components was observed. Photographs showing the impact at a distance of 9" and the typical results after the 30" impact are provided in the appendix of this report.

Photograph 3  
Impact at a distance of 9"

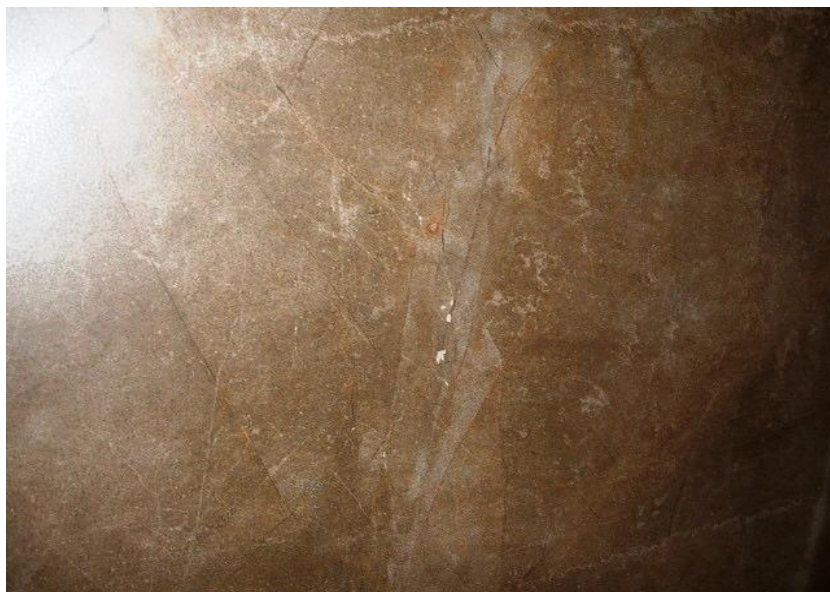
Photograph 4  
Typical results after 30" impact
